Manhole Inspection Summary

Manhole # S33C__043MH

Insp Date: **12/9/08 1:48 PM**

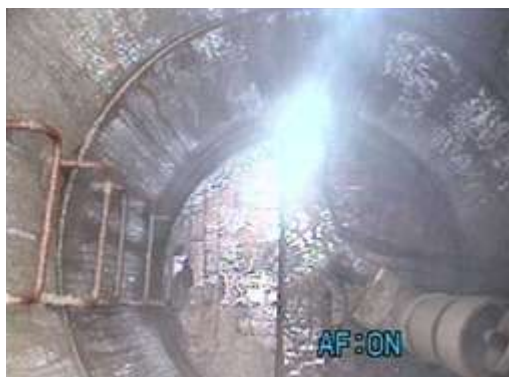
Defect 1

Infiltration: ☐ None ☐ Joint ☐ Cracks ☐ Mortar ☐ Roots ☒ Wall

corbel infiltration

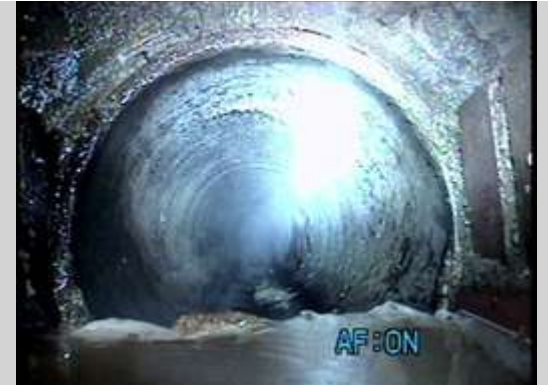
12 O'Clock Outflow

8 in. Circular Gravity Sewer
Pipe Out @ 12 O'Clock

Pipe Material: **Clay** ☐ Pipe Lined

Invert Depth: **9.40** (ft.) Flow Characteristics: **Slow**

Deposits: ☒ None ☐ Mud ☐ Sludge ☐ Debris ☐ Grease

Infiltration: **None** Pipe Seal Cond: **Unknown**

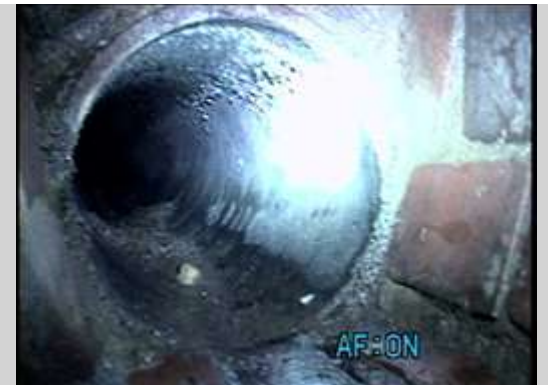
3 O'Clock Inflow

8 in. Circular Gravity Sewer
Pipe In @ 3 O'Clock

Pipe Material: **Clay** ☐ Pipe Lined

Invert Depth: **9.33** (ft.) Flow Characteristics: **None**

Infiltration: **None** Pipe Seal Cond: **Unknown**

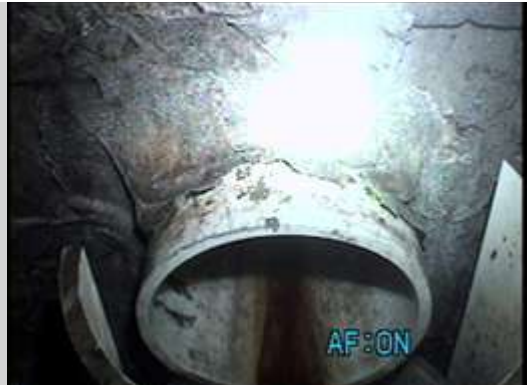
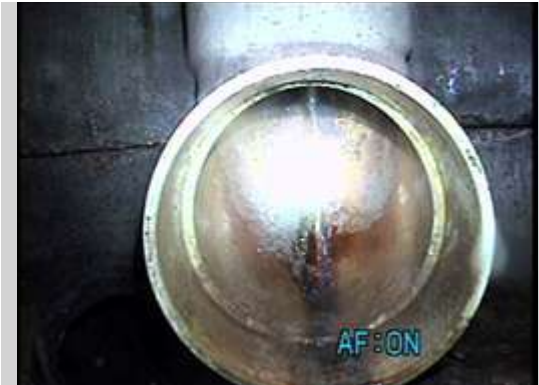
4 O'Clock Inflow

10 in. Circular Gravity Sewer
Pipe In @ 4 OClock

Drop In @ 4 OClock

Pipe Height: **0** (in.) Direct
Pipe Material: **Clay** ☐ Pipe Lined
Invert Depth: **6.00** (ft.) Flow Characteristics: **Slow**
Deposits: ☒ None ☐ Mud ☐ Sludge ☐ Debris ☐ Grease
Silt Depth: **0** (in.) Deposits Extent:
Infiltration: **None** Pipe Seal Cond: **Unknown**

Drop: **Inside** **Direct**
Angled: Reading: **0.00** (ft.)
Inv Depth: **8.75** (ft.)
Drop Condition: **Open**

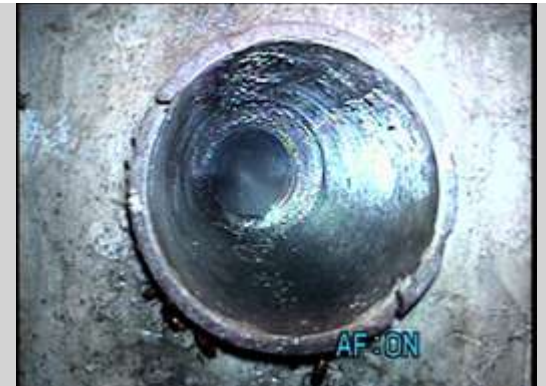
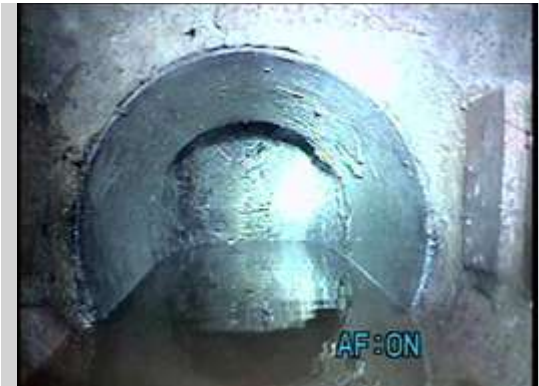
6 O'Clock Inflow

8 in. Circular Gravity Sewer
Pipe In @ 6 OClock

Drop In @ 6 OClock

Pipe Height: **0** (in.) Direct
Pipe Material: **Clay** ☐ Pipe Lined
Invert Depth: **6.26** (ft.) Flow Characteristics: **Slow**
Deposits: ☒ None ☐ Mud ☐ Sludge ☐ Debris ☐ Grease
Silt Depth: **0** (in.) Deposits Extent:
Infiltration: **None** Pipe Seal Cond: **Unknown**

Drop: **Outside** **Direct**
Angled: Reading: **0.00** (ft.)
Inv Depth: **9.36** (ft.)
Drop Condition: **Open**
